Leaffield Parish Council  
St Michaels Church,  
Leaffield,  
Witney,  
OX29 9PG

**Tuesday 21<sup>st</sup> October 2025**

**RE: Arboricultural report – Leaffield Parish Council – Various Sites**

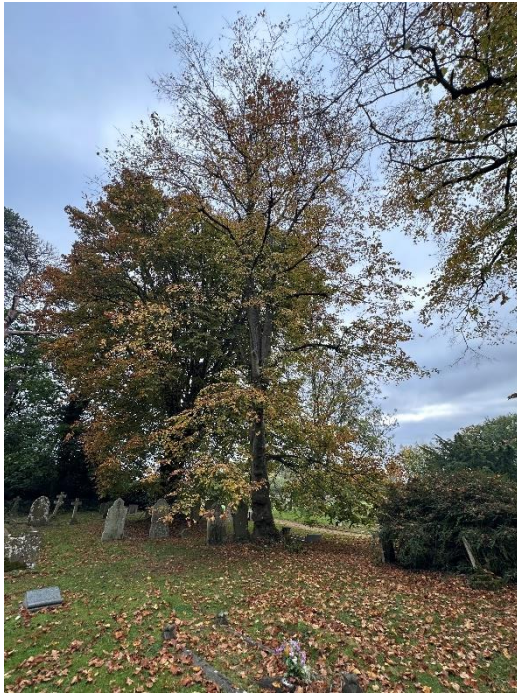
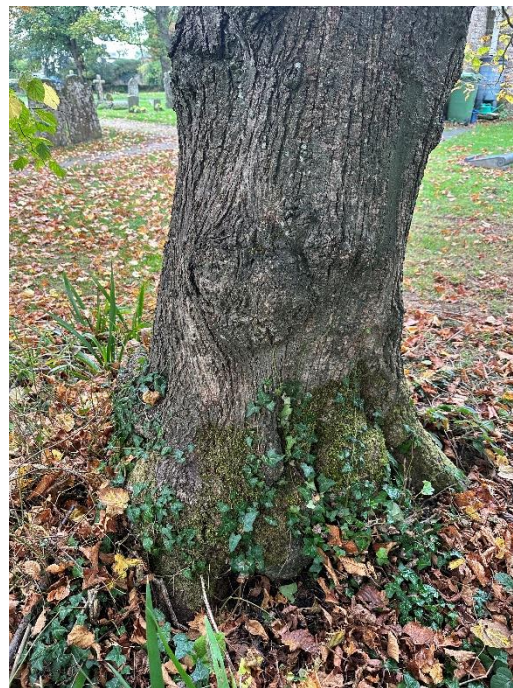
### **T4 Mature Lime – Church Yard - Re-inspect Base**

There is no evidence of any significant decay or dysfunction and the base appears to be clear of any decay, damage or disease.

Our recommendations are no works.

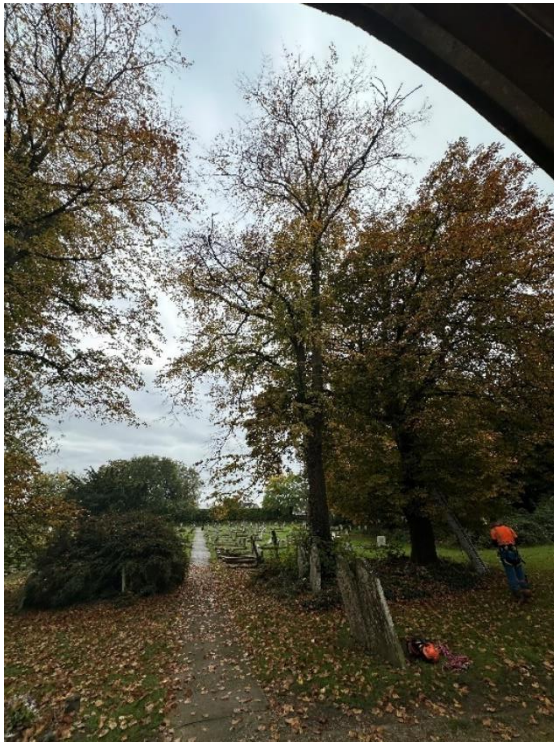
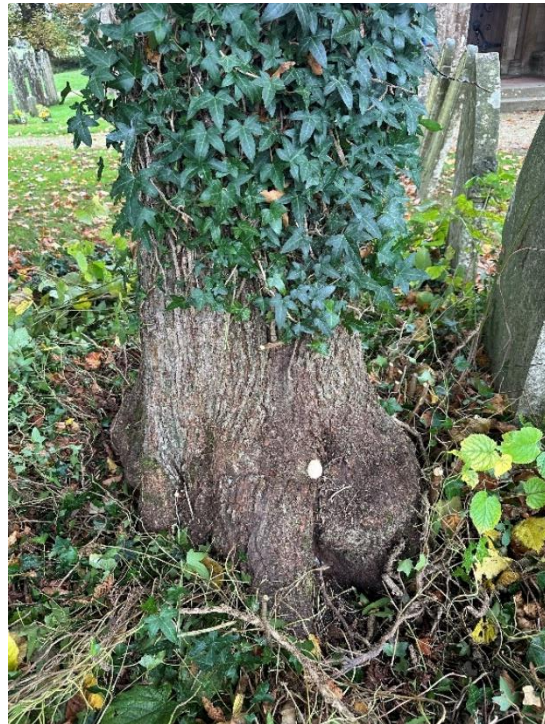
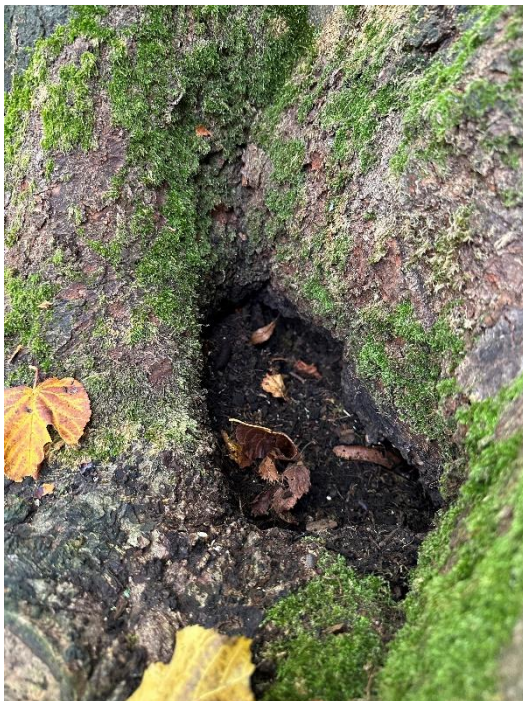
### **T7 Mature Lime - Church Yard - Climbing Inspection and inspect base**

Tree is a lapsed pollard with two co-dominant stems from the pollard head. It is clear that historically there were three. The spot where historically the third section has gone from is now compartmentalised well, relatively dry, no evidence of any significant decay or dysfunction and the base appears to be clear of any decay, damage or disease.

Our recommendations are no works.

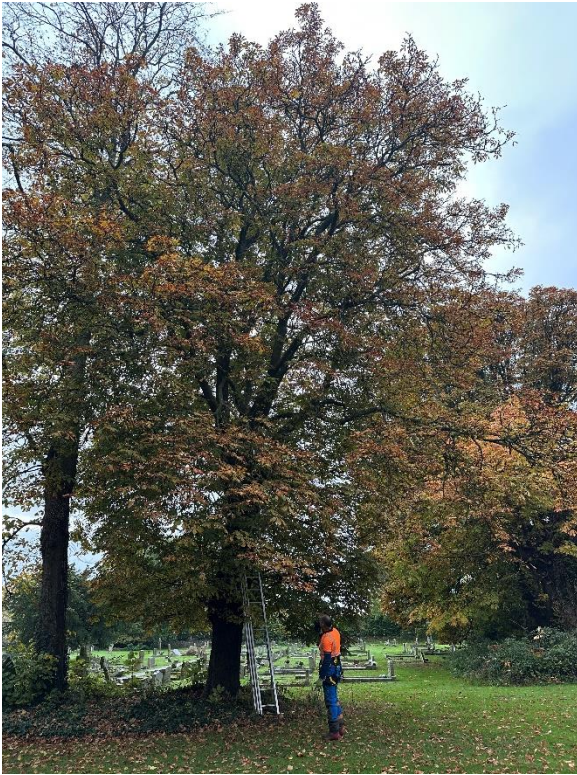
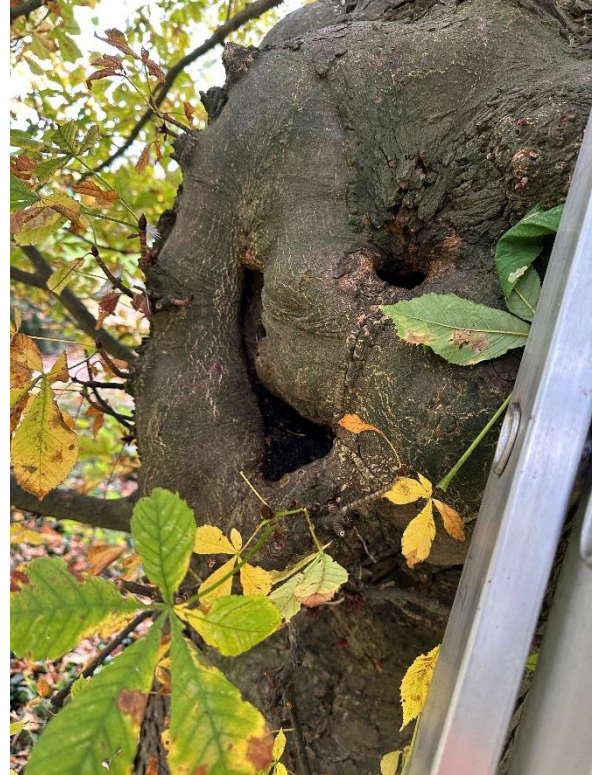
### **T8 Mature Horse Chestnut – Church Yard – Re-inspect Base**

Tree is a lapsed pollard. There is no decay, dysfunction or pathogens around the base. The cavity at approximately 2m above ground level facing the church is 400-450mm deep. Good internal compartmentalisation although the vertical distance internally of the cavity is unknown.

Our recommendations are no works.

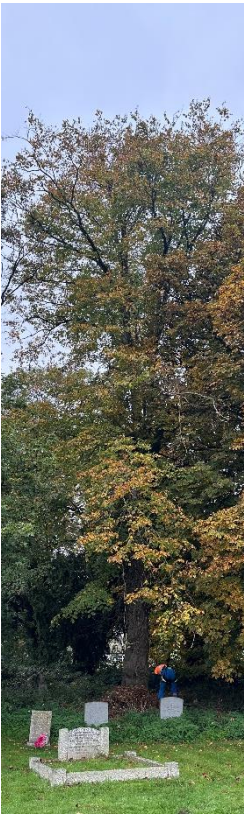
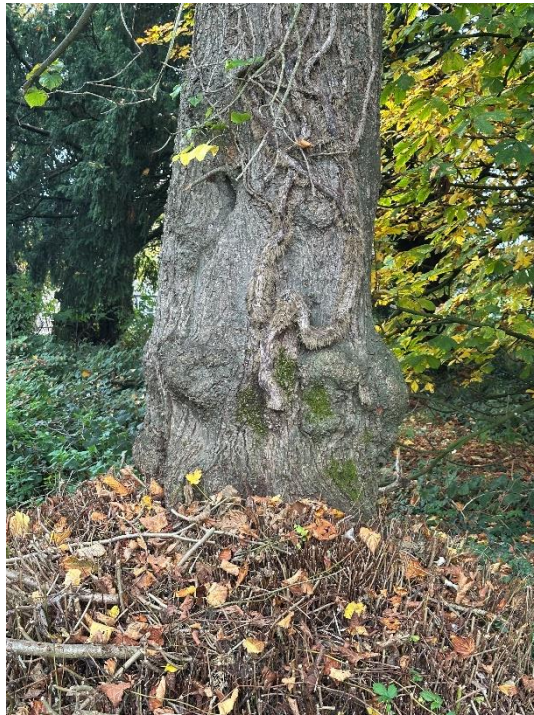
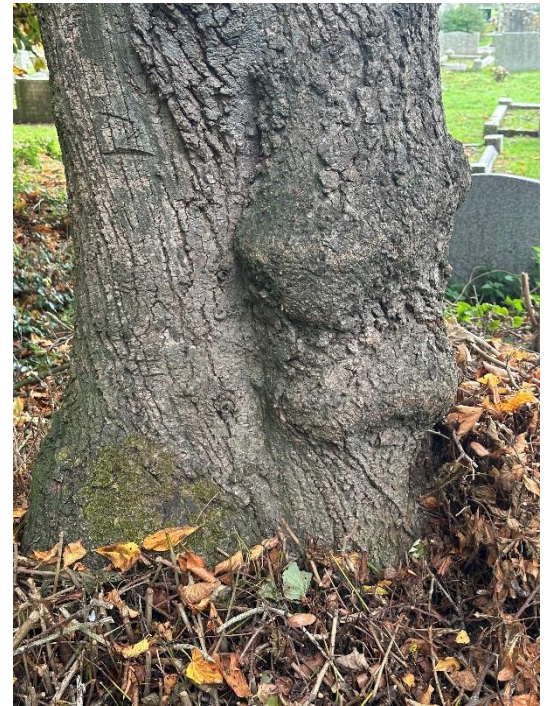
### **T11 Mature Lime – Church Yard - Re-inspect Base**

Tree is a lapsed pollard. There is no evidence of any significant decay or dysfunction and the base appears to be clear of any decay, damage or disease.

Our recommendations are no works.

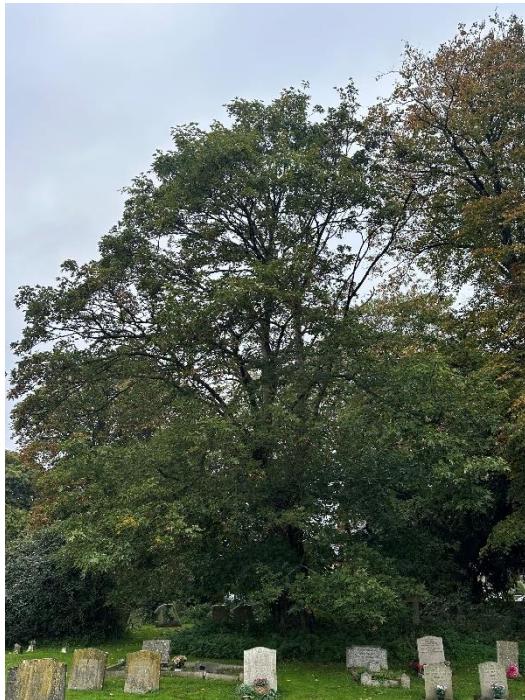
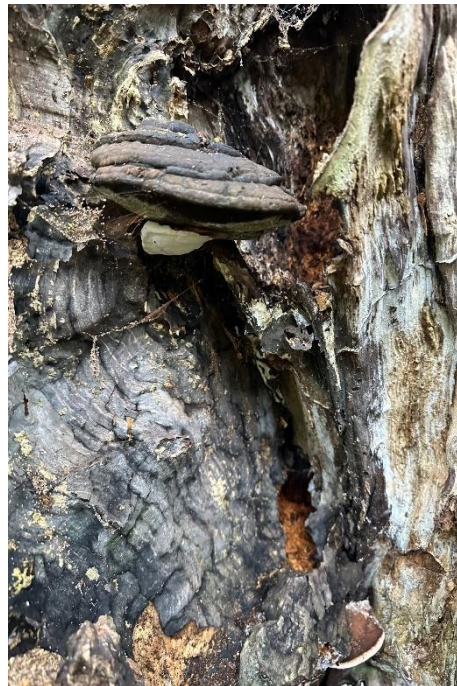
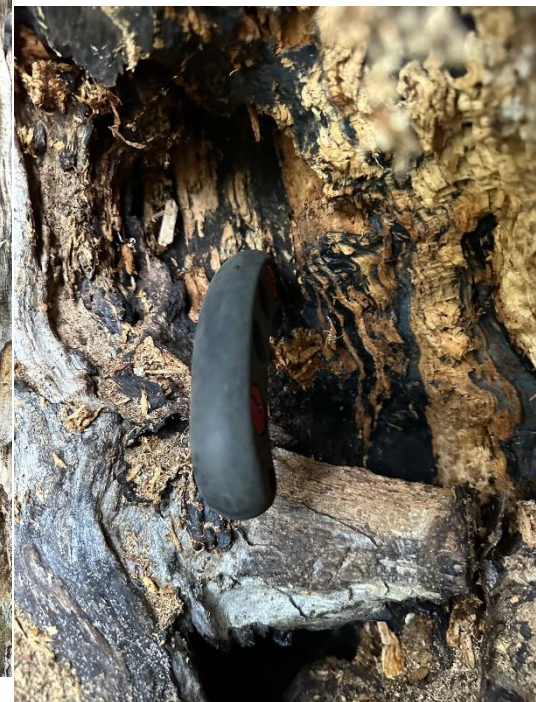
### **T12 Mature/Over-Mature Sycamore – Church Yard – Inspect Main Stem and Base**

Tree is an old pollard with evidence of a significant branch loss at approximately 2m above ground level on the western side. Extensive decay and dysfunction with rotting wood and pathogenic fungi present. Deadwood extends some 300mm past the observed line, *as shown by the photo with the handsaw pressed into the wood.*

Tree has a good form and is relatively sheltered. The site around the wound is compromised to the East with further Ganoderma brackets present on the outside of the tree suggesting the decay goes right through the tree at this point.

Our recommendations are based on the useful life expectancy of the tree. I would recommend the tree is pruned back to the historic pollard point as approximately 4m, leaving some of the low growth as the tree may potentially phoenix from this point, and retain as a habitat monolith which may or may not recover.

Some thought could be given to replanting in this area, as there are several trees and sites of historic tree removals.

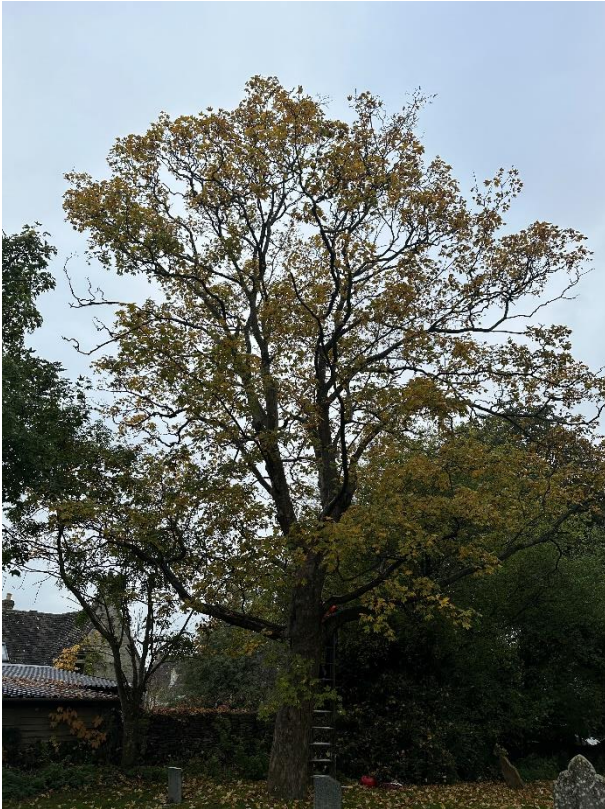
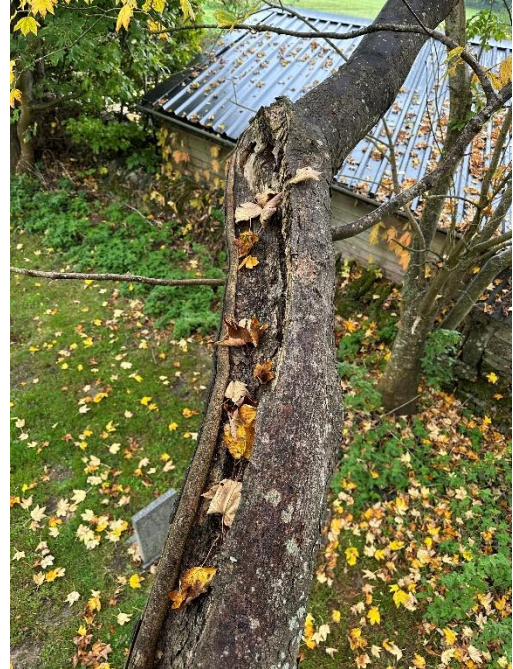
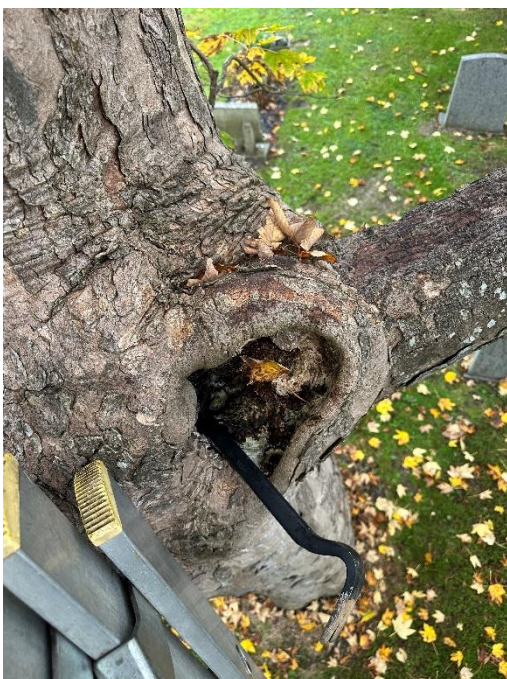
## **T16 Mature Sycamore – Church Yard – Inspect Wound and Re-assess for Further Works**

Tree is fairly squat and evidence to suggest it may have been topped historically. There is evidence also of some branch tear outs and historic branch removals, whether they have failed as a consequence of weather, natural deselection of the tree, or pruning, it is unclear. The main scaffold, emanating over the wall and the neighbours has a large historic wound with decay present and there is a cavity in the main

stem extending some 300mm into the tree. Both wounds seem to have compartmentalised well enough to not warrant any remedial works.

Tree is relatively sheltered and the risk of harm from any nominal potential of failure is low.

Our recommendations are no works.

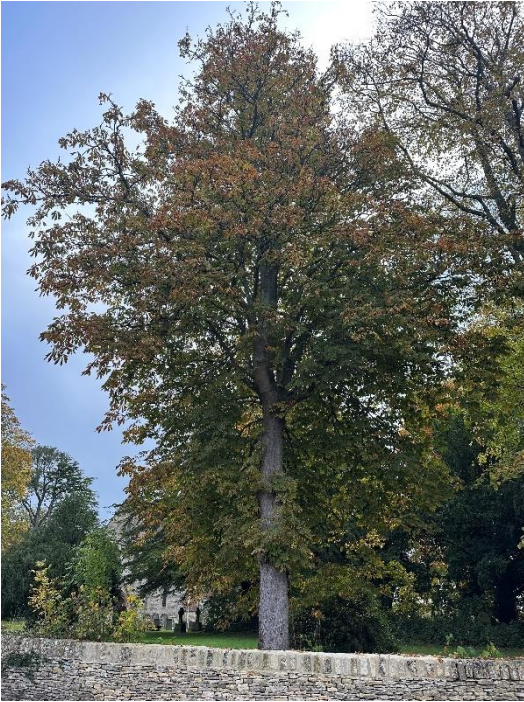
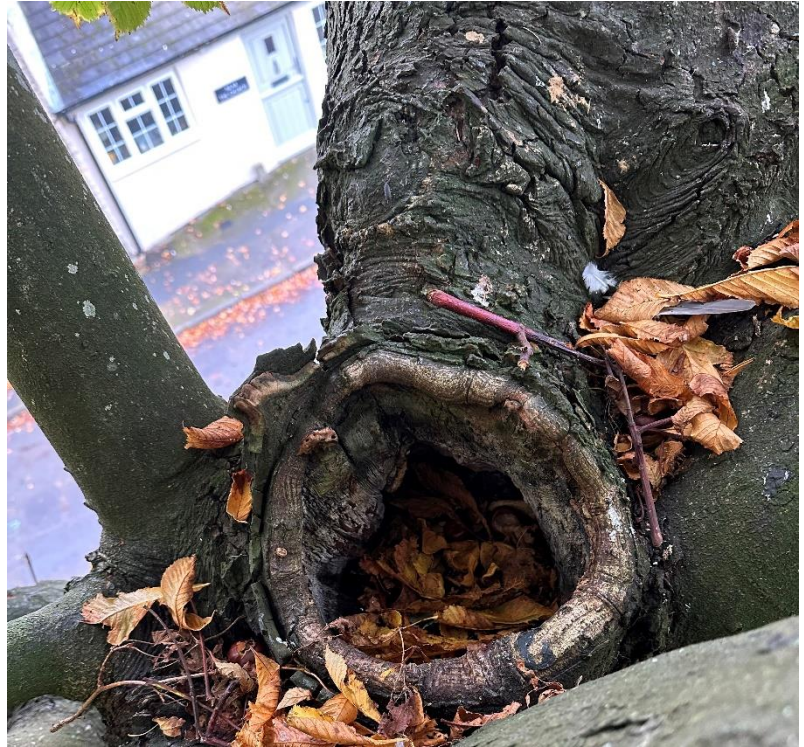
### **T29 Mature Horse Chestnut – Church Yard – Climbing Inspection**

Tree is a lapsed pollard with a wound site in the cup of the pollard head. Probably where the central leader has been historically crowded out by the other main stems and died up. The cavity does extend some 450mm or so down into the centre of the tree.

At this time I do not think this represents a significant structural issue, given the normal quantity of growth around the pollard head and the vibrancy of the crown.

Our recommendations are no works, but to monitor tree and potentially in 2-3 years time reduce tree to mitigate wind loading.

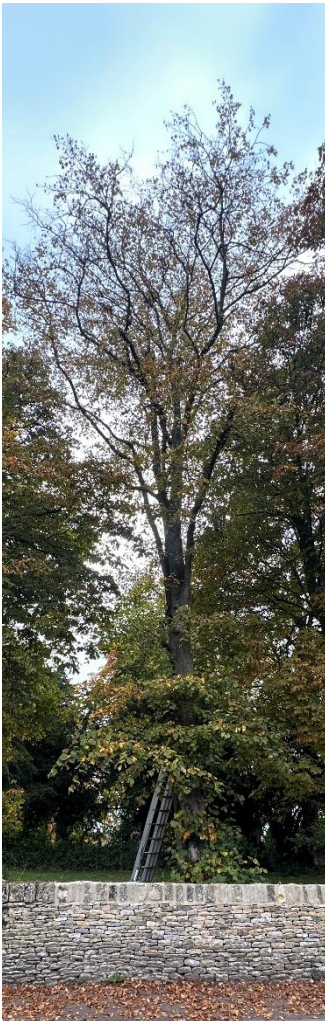
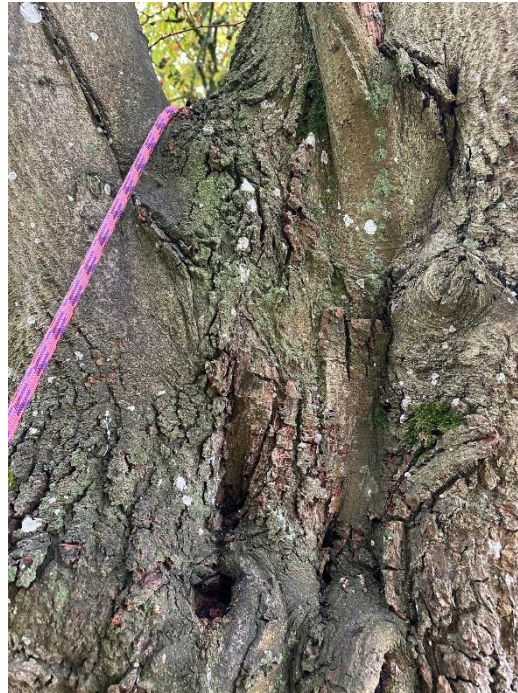
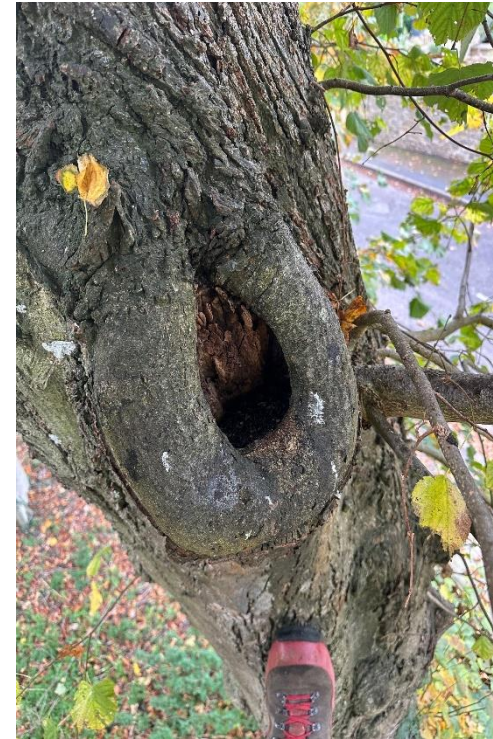
### **T30 Mature Lime - Church Yard – Climbing Inspection**

Tree is a lapsed pollard. All of the cavities from old pruning wounds appear to have compartmentalised well with good reactive growth and solid sound wood behind the back edge.

Our recommendations are no works.

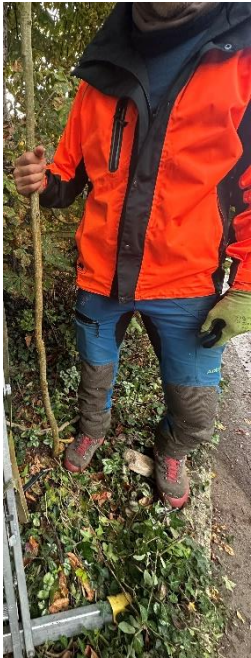
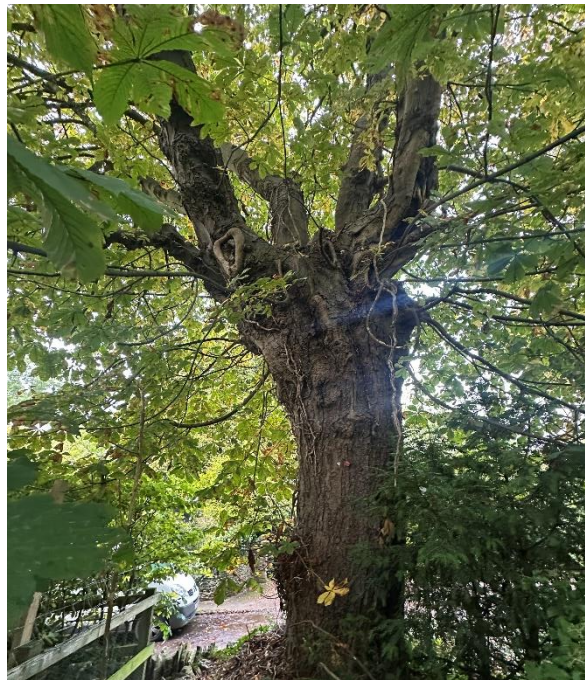
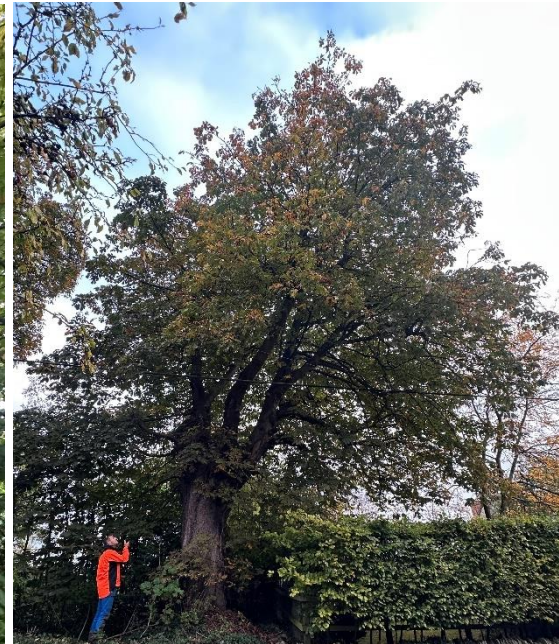
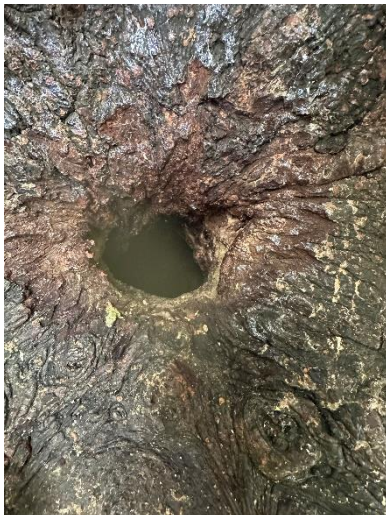
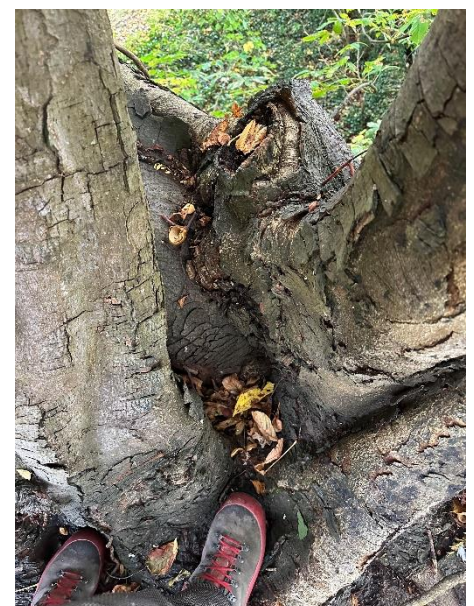
### **T35 Overmature Horse Chestnut – Church Yard – Climbing Inspection**

The pollard head appears to be free from any significant pathogenic dysfunction. The main scaffolds all have some form of defect, whether its an old tear out with decay present or historic beam cracks (internal cracking along the line of the scaffold). The tree has a significant cavity in the pollard head, extending some 1.4m in, please see photo of stick, cavity extending from bottom of stick to hand. Tree has been reduced historically. There is also evidence of Pseudonymous Syringe on the main stem.

My recommendations would be to reduce the upper canopy by 2-2.5m to mitigate wind loading and the stresses on the weakened scaffolds, retaining as much of the low level foliar material as practicable, leaving a balanced and flowing crown outline.

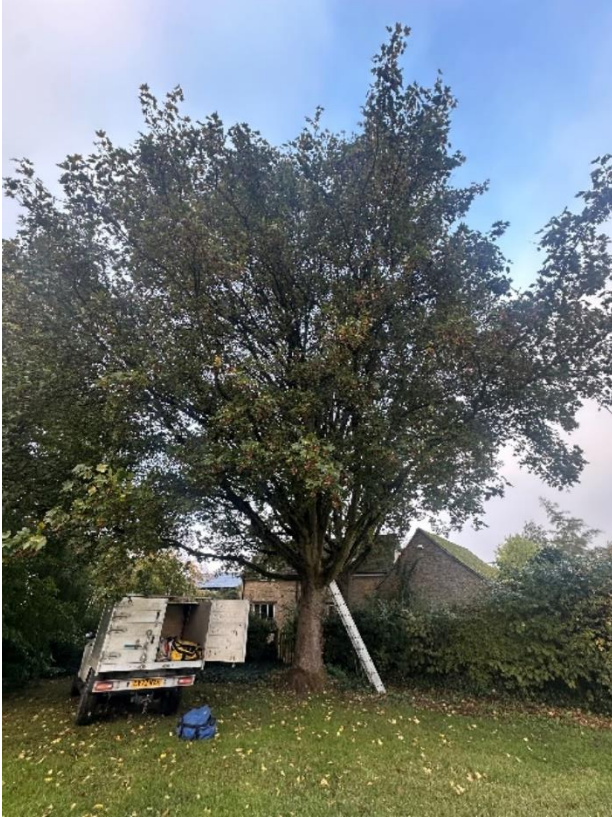
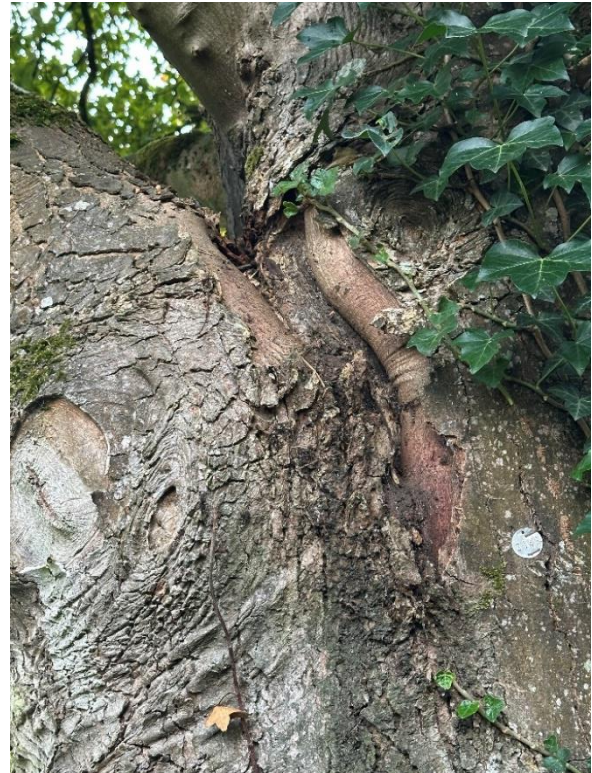
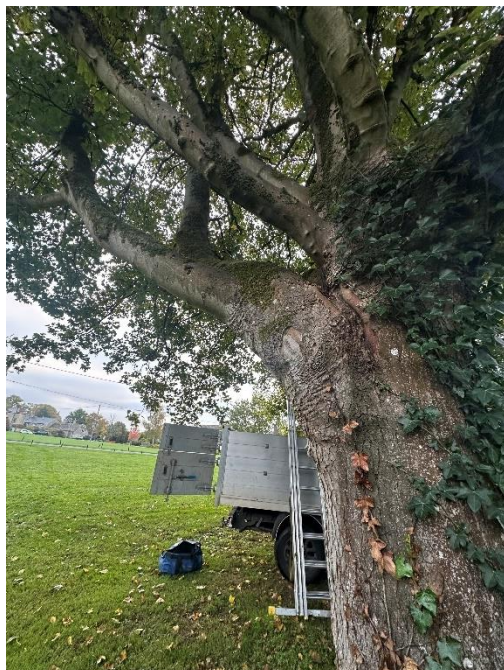
### T49 Mature Sycamore – The Green – Re-inspect Base

Section to the East emanating from crown break with bark dysfunction and decay at the main branch union.

Our recommendations would be to reduce this section by 1.5-2m, pruning to points of suitable secondary live growth to promote a balanced and flowing crown outline to mitigate the stress on the branch union.

Defect should be monitored annual for further signs of degradation.

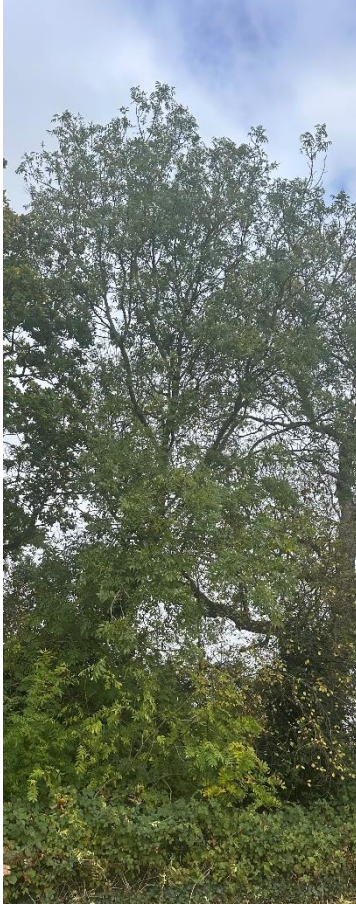
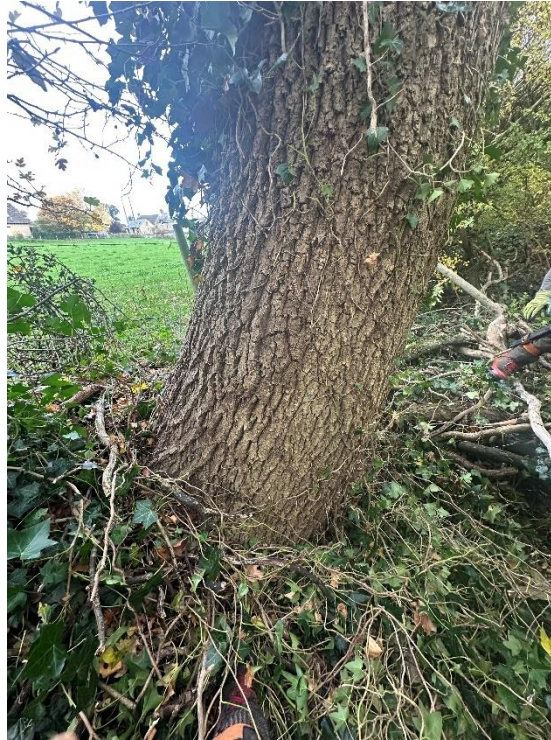
**T94 (Tag is T93) Over-Mature Ash – Playing Field - Full Basal Inspection**

There is extensive dieback. There is no obvious decay or dysfunction at the base although the tree is clearly declining.

Our recommendations are no works.

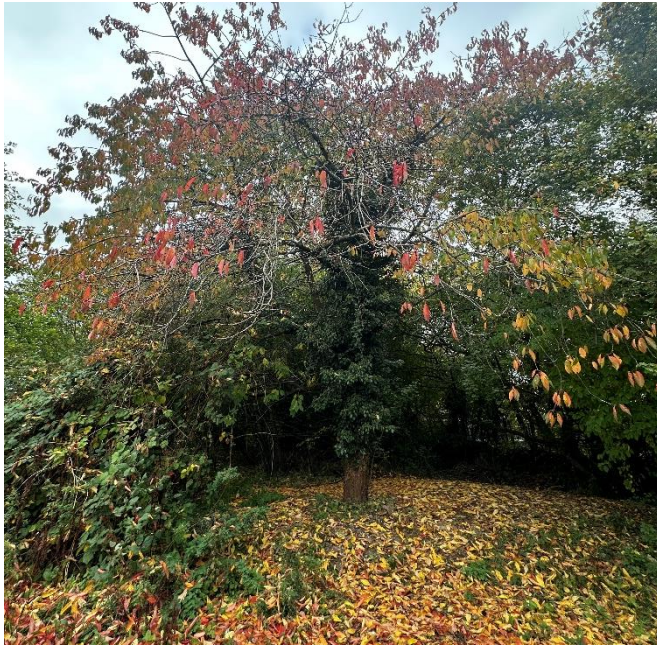
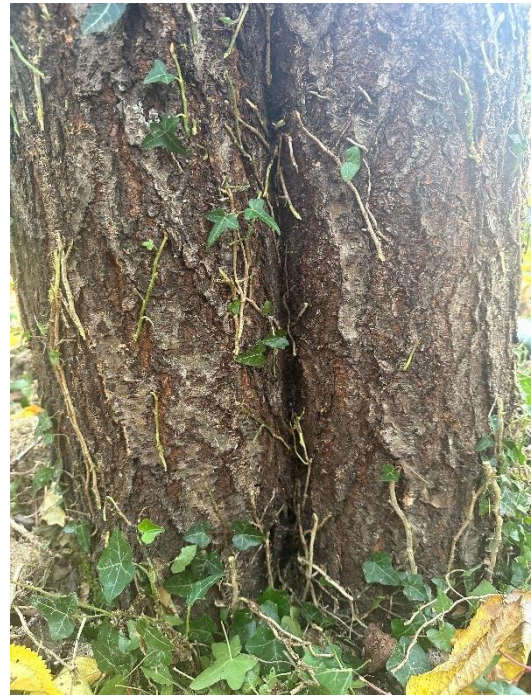
### **T101 Mature Cherry – Playing Field - Re-inspect Base**

Tree has had historic spoil from ground works, stacked and packed around the base up to approximately 500mm. this doesn't appear to have unduly impacted on the tree although is far from ideal. There is an anomaly in the trunk, vertically to the East which doesn't appear to be affecting the stability of the tree. There is no pathogens or decay or other dysfunction.

Our recommendations are no works.
