# Safety Inspection Report

Annual Inspection

## Play Area

Leafield Parish Council

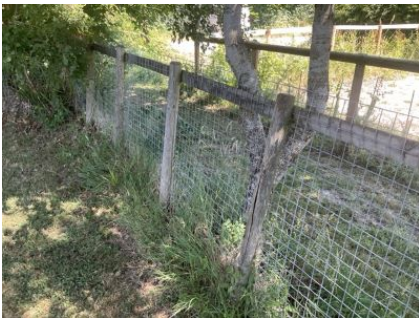
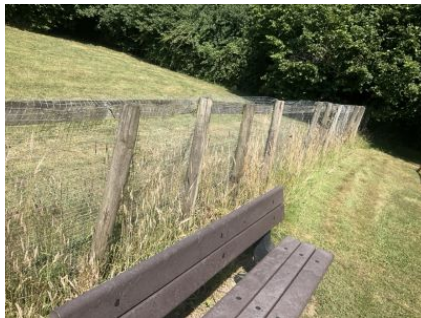
There is decay to timber components which may affect structural integrity. We do not recommend replacing rotten supports with timber posts which are directly set in the ground due to the increased problem of timber rot, especially in posts in contact with the ground.

Rot/decay to posts and rails. Monitor and replace when necessary.

Replace decayed components where possible and plan replacement of item. Check on a routine basis, especially at ground or foundation level.

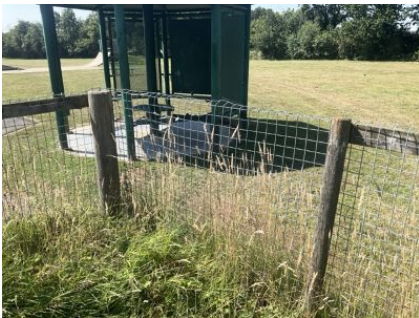
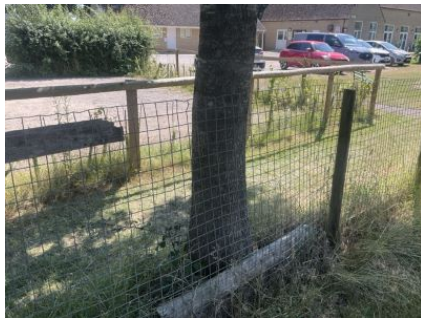
Fixtures loose or missing.

Replace.

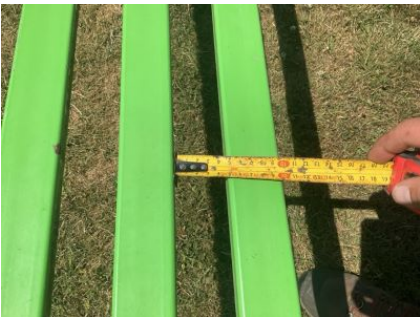
The gaps between the slats exceed 30 mm and are known to cause entrapments.

No reasonably practicable action is identified.

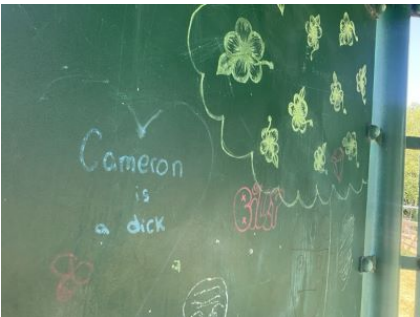
There is offensive graffiti on the unit.

Remove.

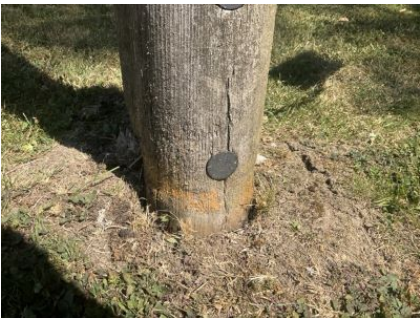
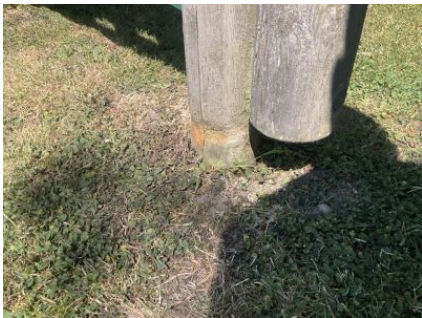
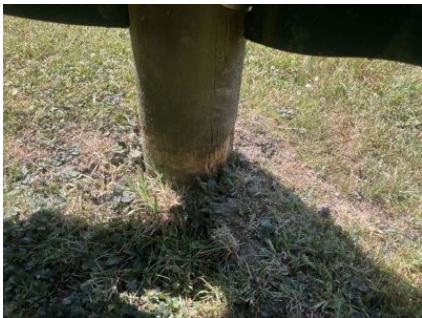
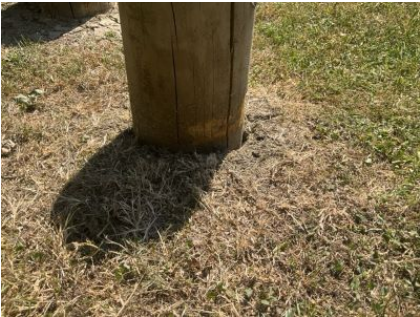
Strimmer damage is present on posts, allowing water to enter and timbers to soften. It can also remove the protective envelope around the timber. Prevent further damage and check timbers for decay throughout the year.

Prevent further damage.

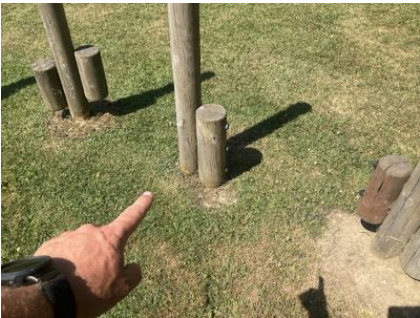
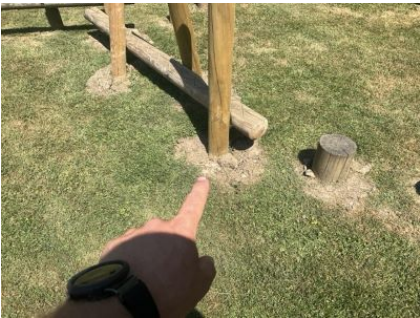
Loose in ground.

Monitor.

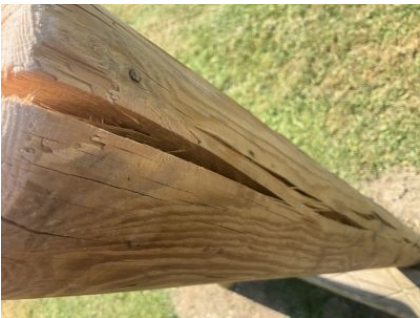
There are natural splits / shakes in the timbers.

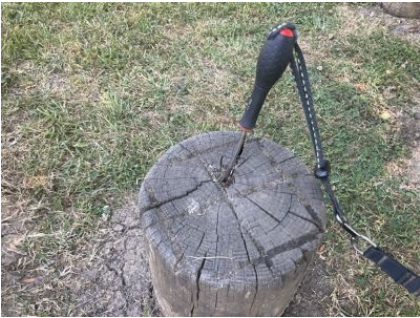
Timber is decayed.

Check on a routine basis.

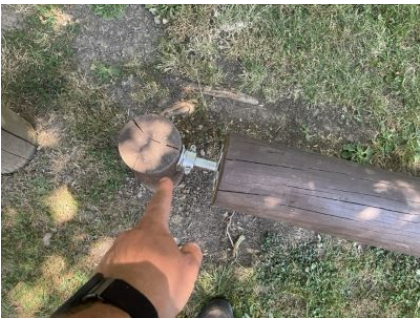
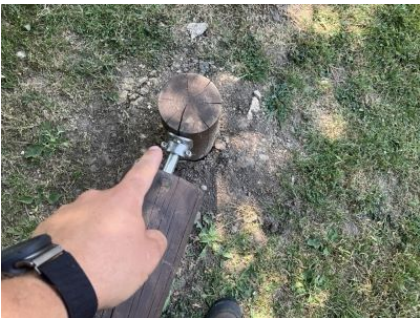
Bolt(s) loose.

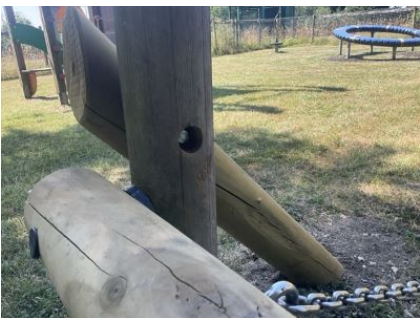
Cap missing.

Replace.

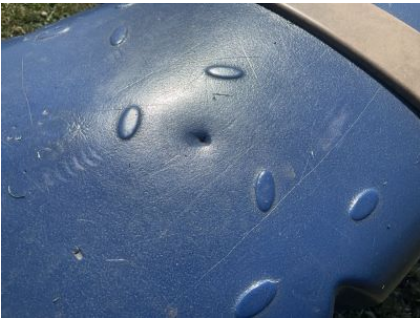
Item is cracked.

Rotating top is cracked in places. Monitor and plan for replacement.

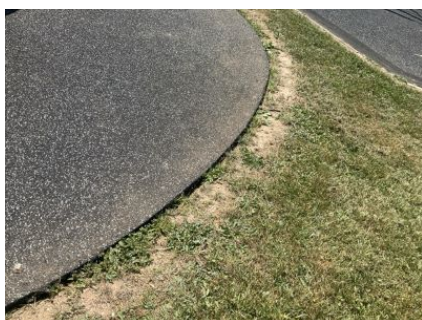
Shrinkage / separation of the surface. This may give a trip hazard.

Repair., Allow grass to establish in the gap, as this may prevent the wet pour from shrinking further.

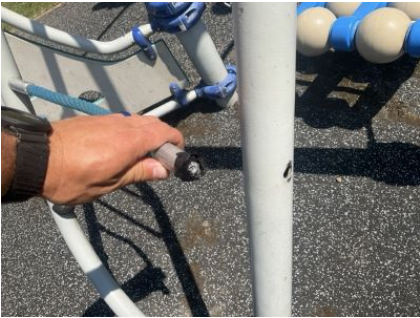
Bolt(s) missing.

Replace missing bolt(s).

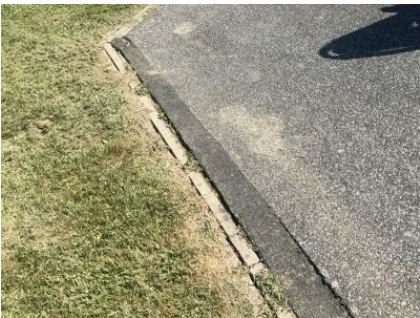
Shrinkage / separation of the surface. This may give a trip hazard.

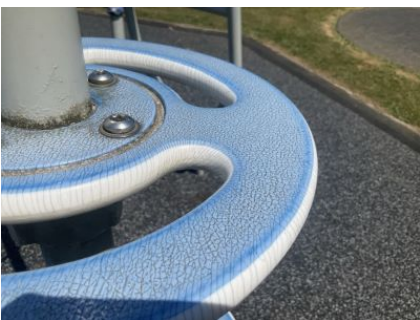
Item is cracked.

Plastics are cracked. Monitor.

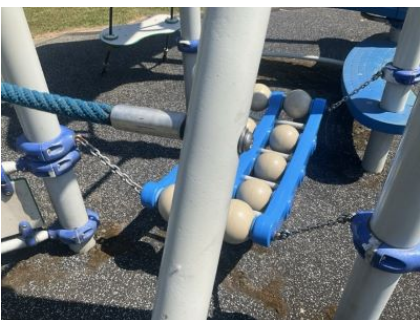
The surface is damaged.

Bolt(s) loose.

Repair.

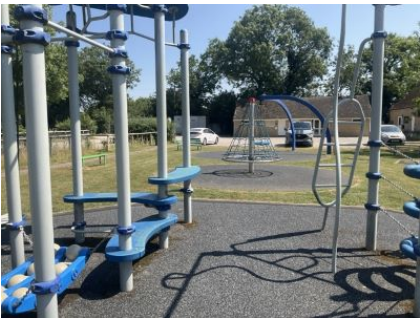
Item has some parts missing.

Replace the missing parts.

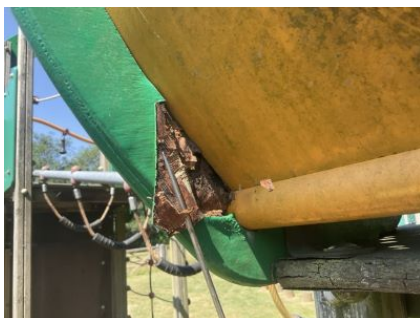
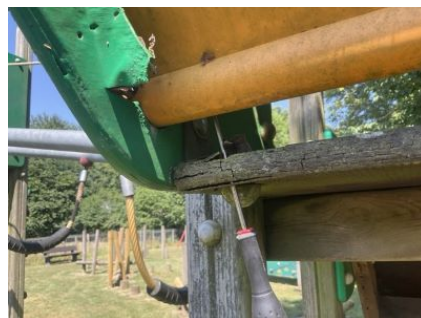
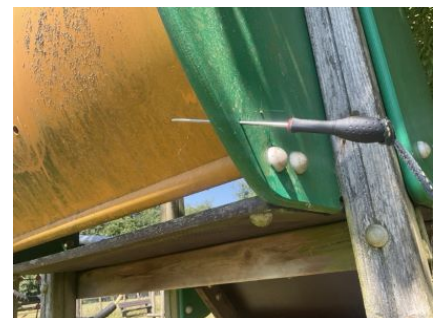
Timber is decayed.

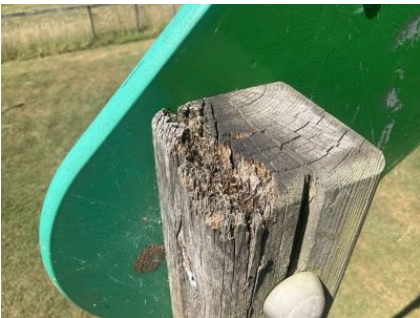
Timber is decayed.

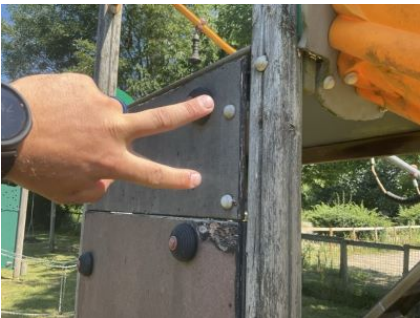
Fixtures loose or missing.

Tighten/replace.

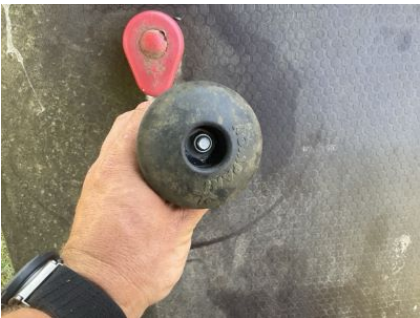
Cap missing.

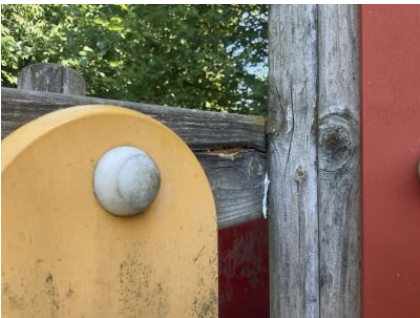
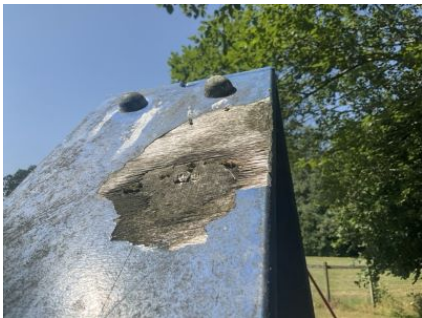
Timber is decayed.

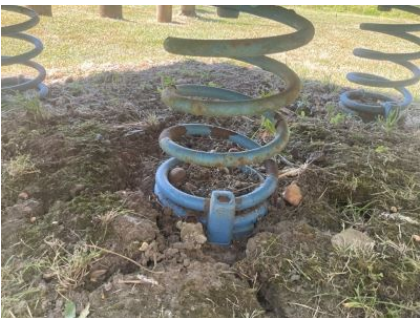
The spring is rusty. These have been known to fail without warning, leading to a collapse of the unit.

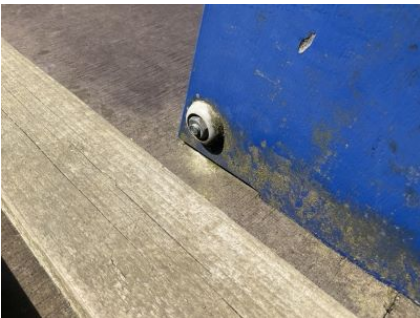
Cap missing.

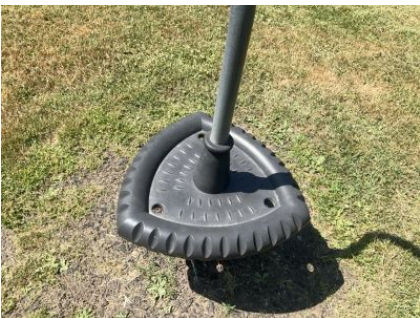
There is wear in the bearings.

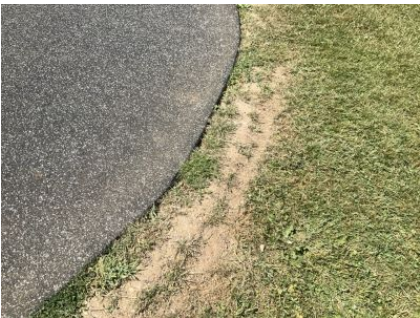
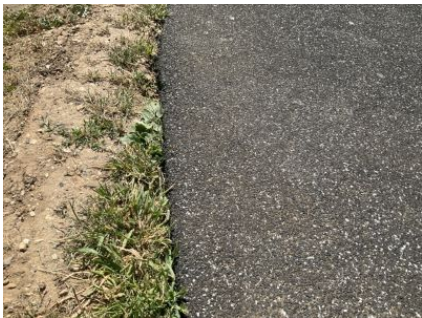
Shrinkage / separation of the surface. This may give a trip hazard.

Repair., Allow grass to establish in the gap, as this may prevent the wet pour from shrinking further.

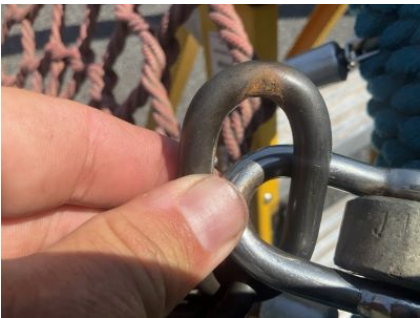
| Chain link connectors notched. | Replace worn parts. | 4 |

Replace worn parts.

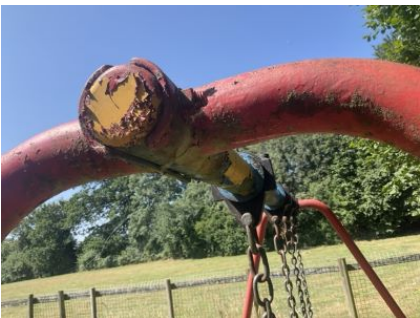
Paintwork is in poor condition.

De-scale back to good base material and coat with lead free paint, using appropriate precautions. Repairs may be necessary where corrosion is severe.

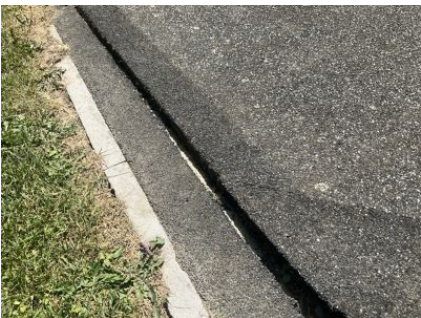
Shrinkage / separation of the surface. This may give a trip hazard.

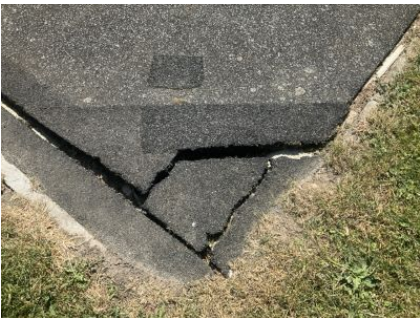
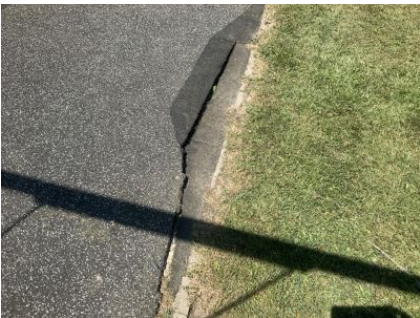
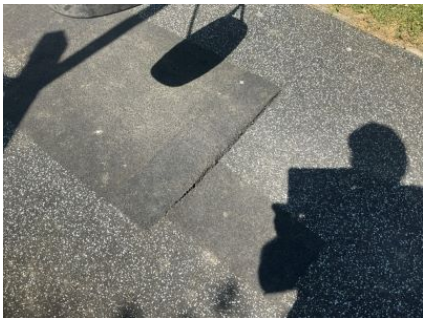
The surface is damaged.

Repair.
