# Safety Inspection Report

Annual Inspection

## Skate Park

Leafield Parish Council

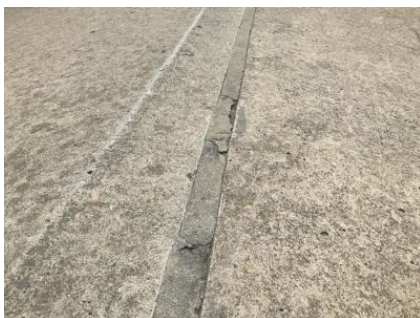
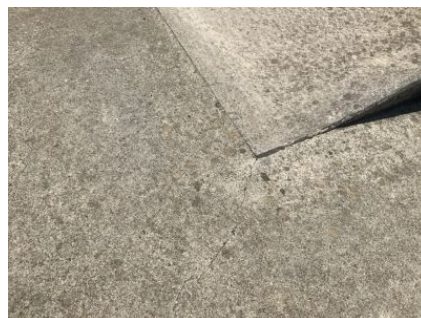
## Skate - Driveway

| Description | Tasks | Risk score |
|---|---|---|
| Concrete edges are in poor condition. | Repair. | 3 |

Concrete edges are in poor condition.

## Repair.
