# Safety Inspection Report

Annual Inspection

## Play Area

Leafield Parish Council

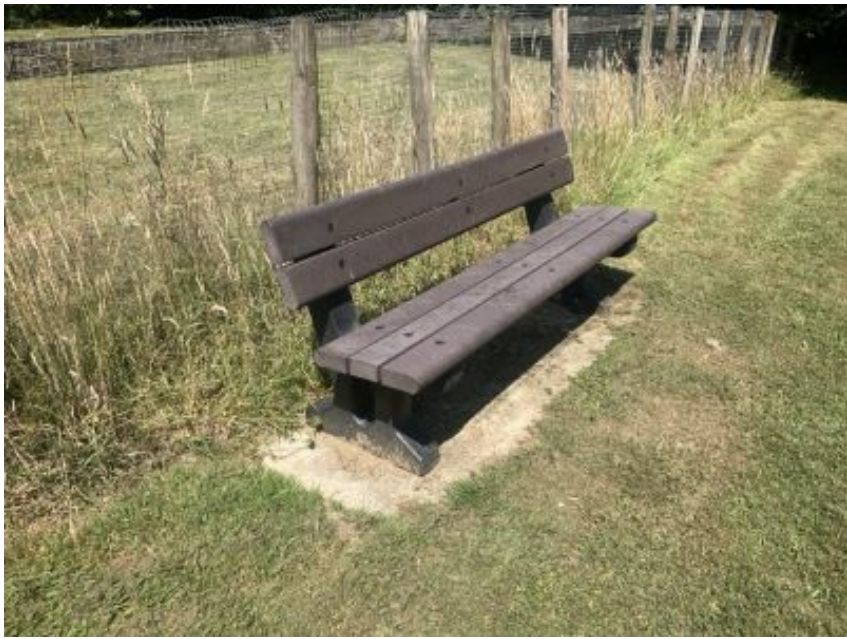
# Seating

The gaps between the slats exceed 30 mm and are known to cause entrapments.

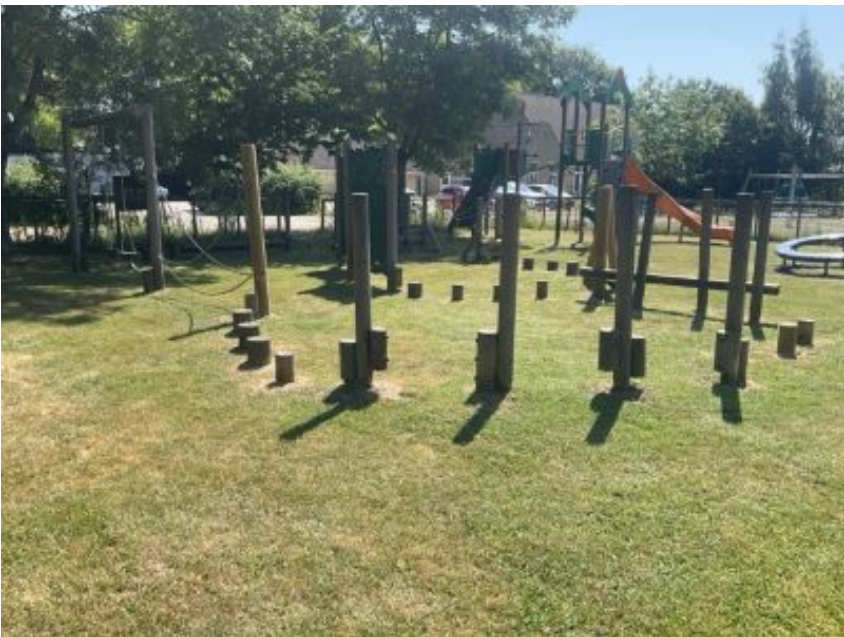
# Agility Trail

Strimmer damage is present on posts, allowing water to enter and timbers to soften. It can also remove the protective envelope around the timber. Prevent further damage and check timbers for decay throughout the year.

Loose in ground.

Timber is decayed.

Bolt(s) loose.

Cap missing.

Prevent further damage.

Replace.

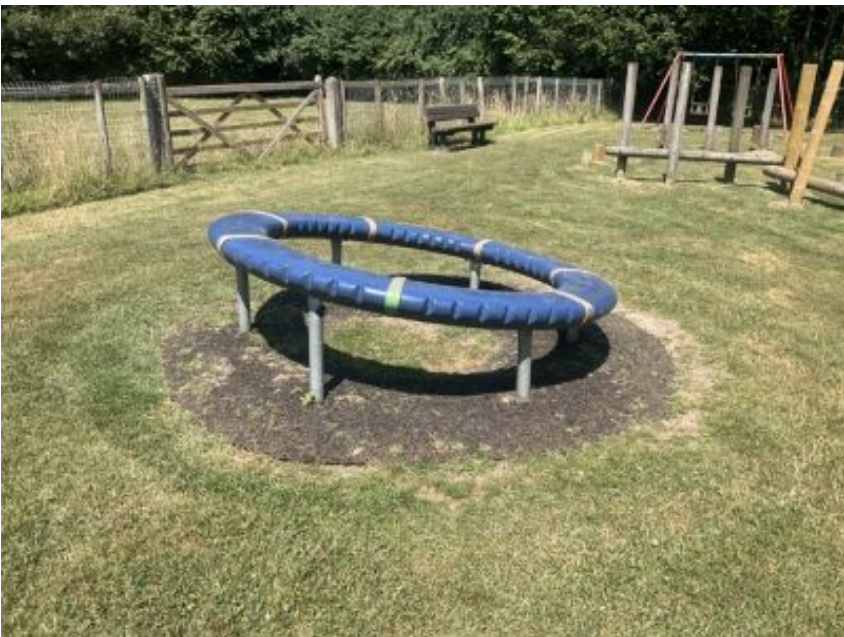
# Carousel - Supernova

Item is cracked.

Rotating top is cracked in places. Monitor and plan for replacement.

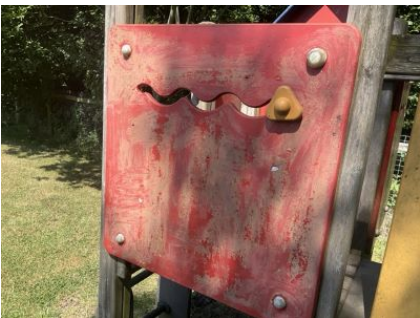
Timber is decayed.

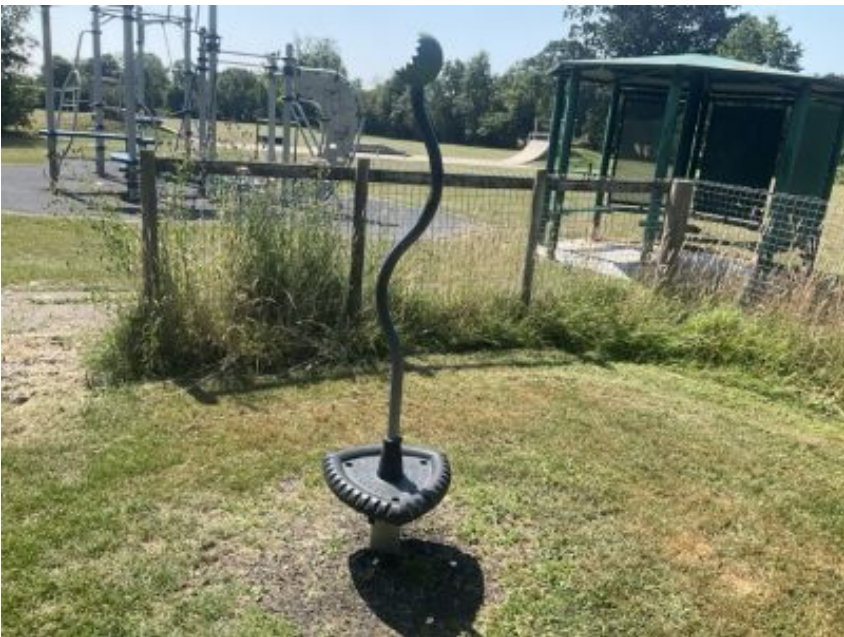
# Rotator - Spica

There is wear in the bearings.

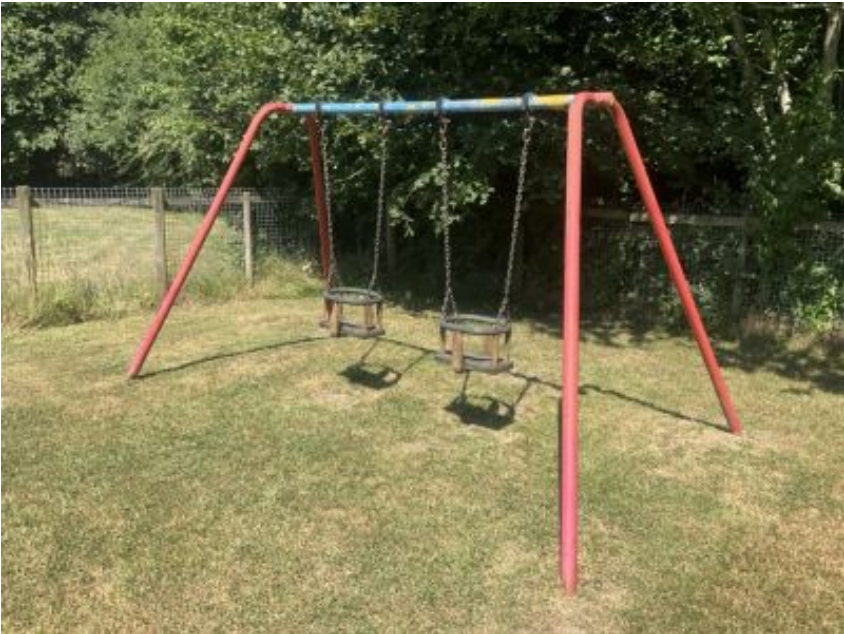
# Swing - Toddler - 1 Bay 2 Seat

Paintwork is in poor condition.
